**Archimedes Screw Turbine Fisheries Assessment.  
Phase II: Eels and Kelts.**

**Client: Mann Power Consulting Ltd.**

**March 08**

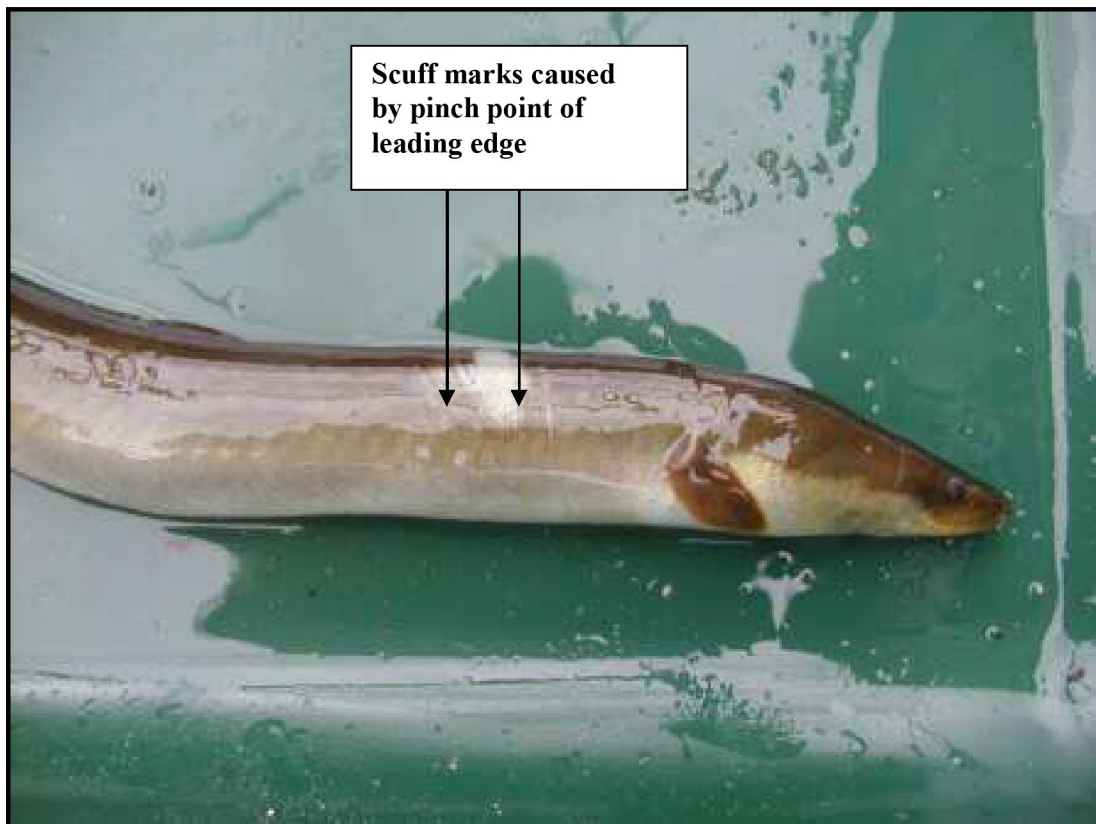
The results are shown in table 1. One out of a total of 12 eels (8%) suffered a severe pinch mark behind the head and a damaged spine, see figure 3. It is unlikely the eel would have survived long term. The scuff marks on the skin suggested that the eel had been trapped by the overhang of the leading edge, shown in figure 4. Placing the eel under the overhang confirmed this, as it fitted exactly into the 20mm gap.

**Figure 3. Eel caught in pinch point**

Before continuing with the trials, it was decided to modify the edge by cutting it back so it ran within the trough, removing the bevel and pinch point. The modified leading edge is shown in figure 5.

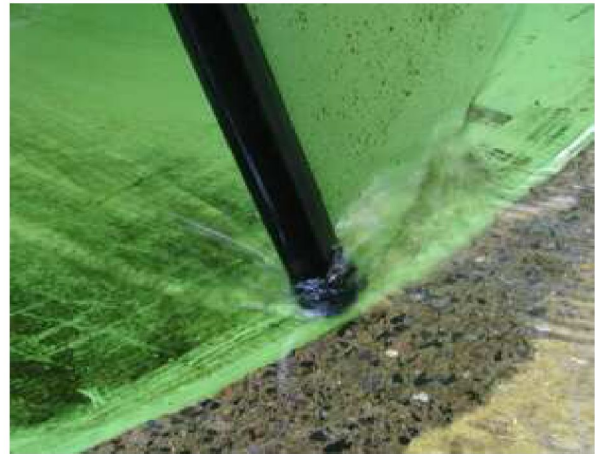
Figure 5. Modified edge

It was evident that modifying the leading edge had resolved the issue of eels being trapped and damaged by the pinch point. This was confirmed by a Chi-squared comparison of results before and after modification. (Chi-squared test,  $p=0.02$ ).

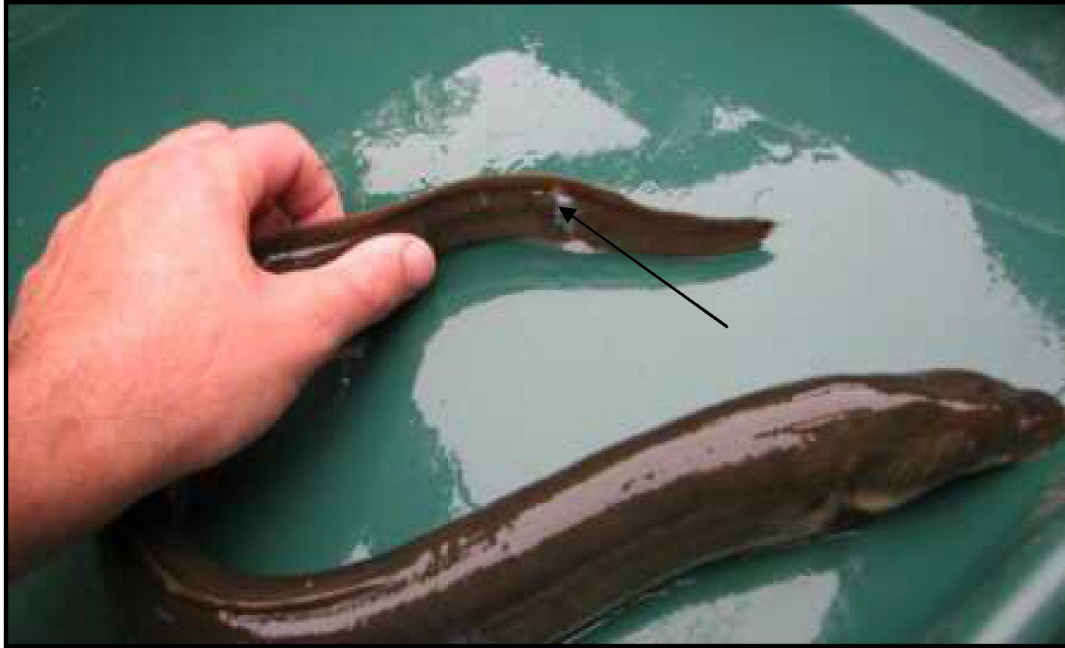
160 passages through the turbine were recorded across a range of speeds as shown in table 2. One eel suffered minor damage in the form of a pinch 5cm from the end of the tail (see figure 8), probably caused by the tail sliding under the 5mm gap between the screw helix and the trough. All the eels were alive and appeared healthy after 7 days in holding tanks. The damaged eel was observed for a further 7 days (14 days in total) after which it was released into the river. It was concluded that the damage to the tail was recoverable and the risk to eels from passing through the screw negligible. Overall the mortality rate was 0%, with less than 1% (0.64%) suffering minimal and recoverable damage.

**Figure 8. Eel with pinched tail**

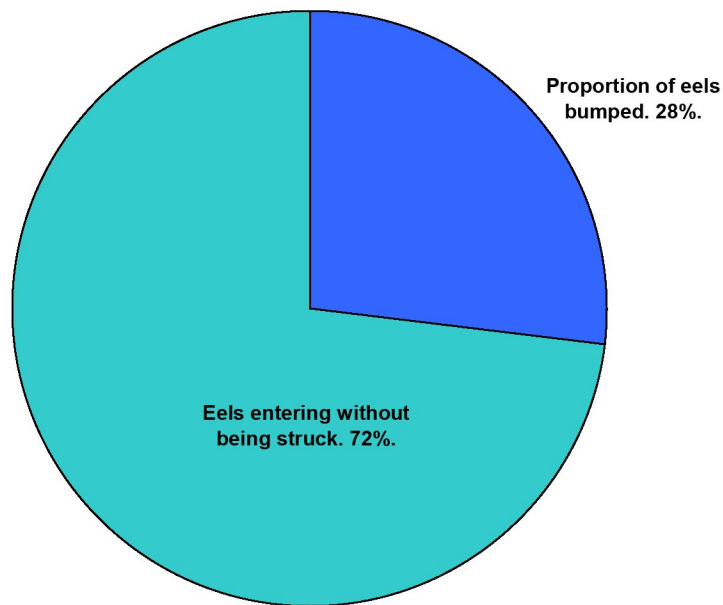
Eels entered the turbine along the floor of the forebay tank as expected. The majority passed through without being bumped by the leading edge, approximately 28% were struck, as shown in figure 9. No damage was inflicted, suggesting that the maximum speed of 3.8m/s towards the periphery of the helix is too low to cause injury.

**Figure 9. Proportion of eels struck by leading edge**

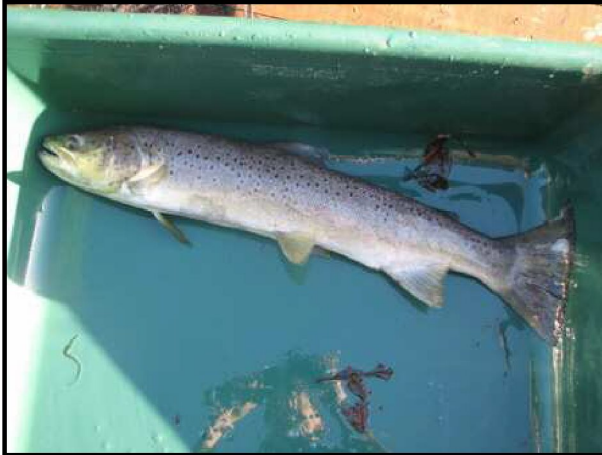
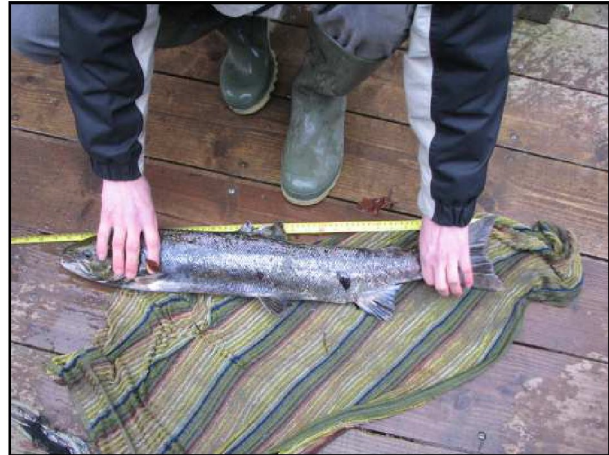
While none of the fish were damaged by passing through the screw, some were in poor condition, with bacterial/fungal lesions and fin rot. This is not unusual, especially for spring run fish that may have been in the river for at least 6-8 months. One of the smaller sea trout kelt and a 77cm salmon kelt are shown in figures 13 and 14 below.

Figure 13. Sea trout kelt.

Figure 14. Salmon kelt

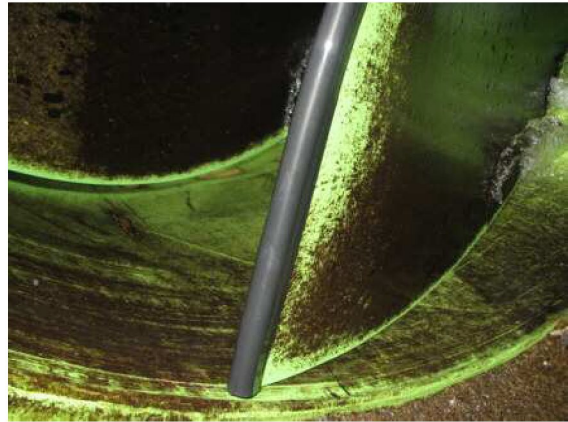
The bumpers fitted to the leading edge were assessed after 8 months of continuous operation. They were in perfect condition (see appendix) and could be expected to last for 5-10 years.

**After 8 months of operation**

The leading edge must be modified by removing the bevel and any overhang of the trough. Extruded rubber profiles (fish bumpers) should also be fitted to protect larger fish in particular. While the bumpers are extremely durable, they should be inspected during routine maintenance, every 6 to 12 months.
