**Master Thesis, Department of Geosciences**

# **Landslide Hazard Mapping in Norddal, Møre og Romsdal**

*A case study and review of landslide hazard mapping according to current requirements of the Norwegian Water Resources and Energy Directorate (NVE)*

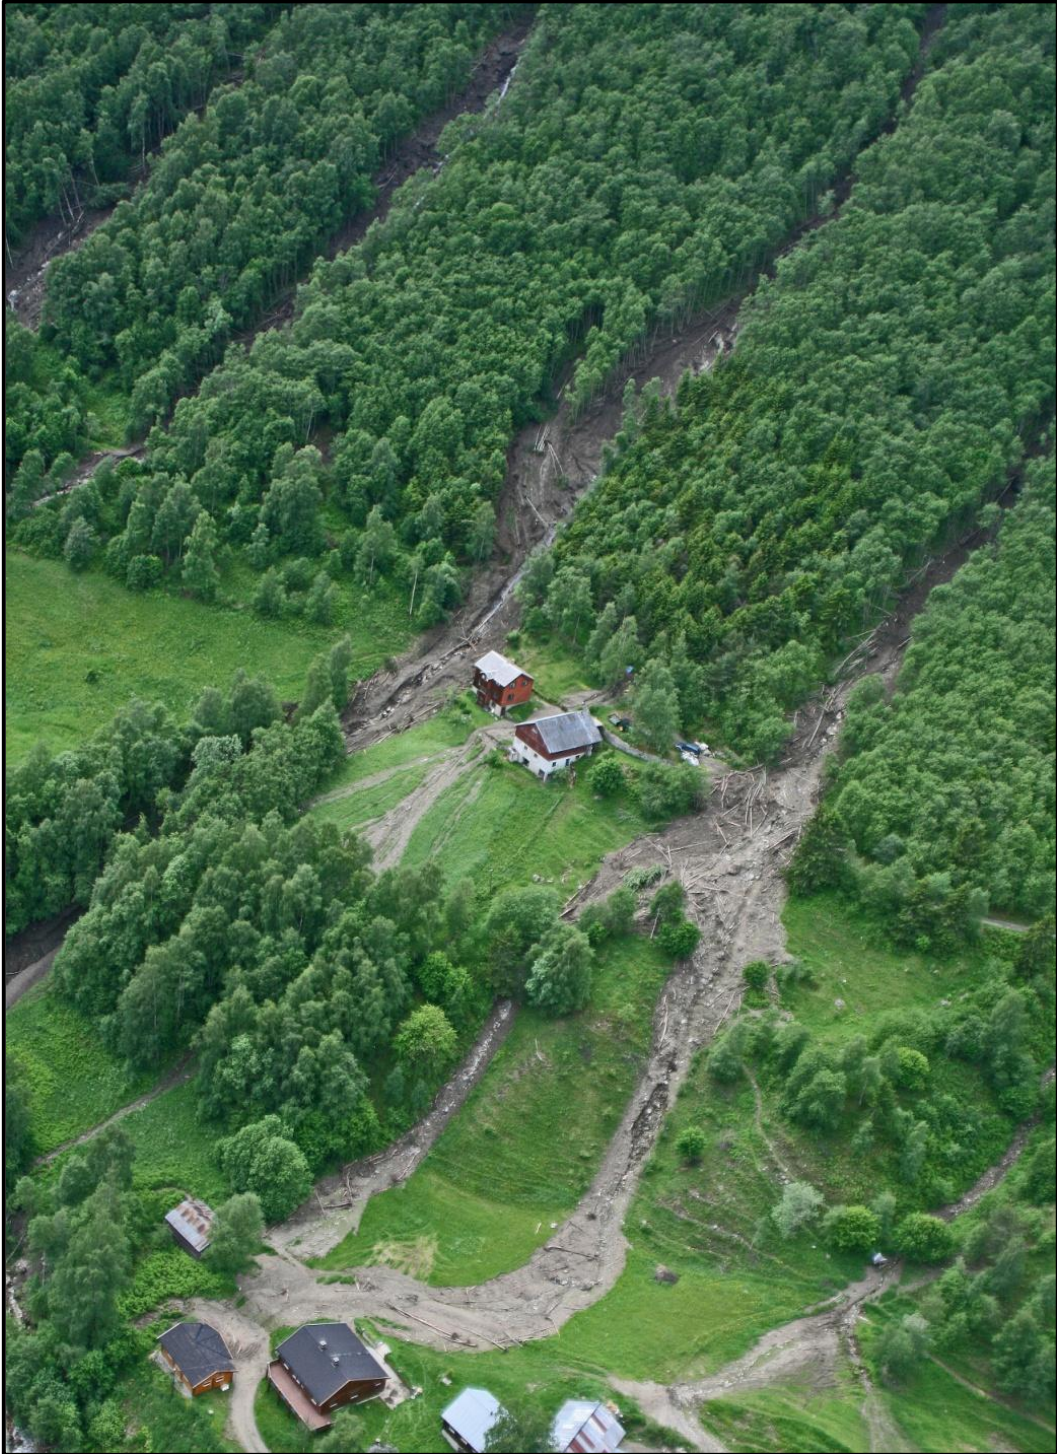
*Figure 2-3: Debris flows near Kvam in Gudbrandsdalen. Several debris slides and flows occurred in the area during three days of heavy rain in June 2011 (Photo: A.T. Hamarsland, NVE).*

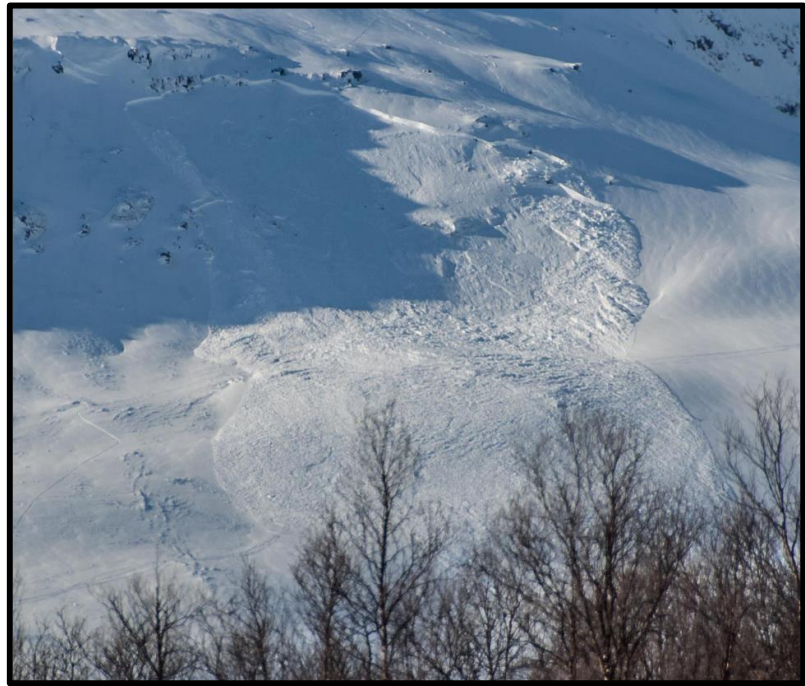
*Figure 2-4: Slab avalanche from Tamokdalen, northern Norway (Photo: Kristin N. Heggland).*

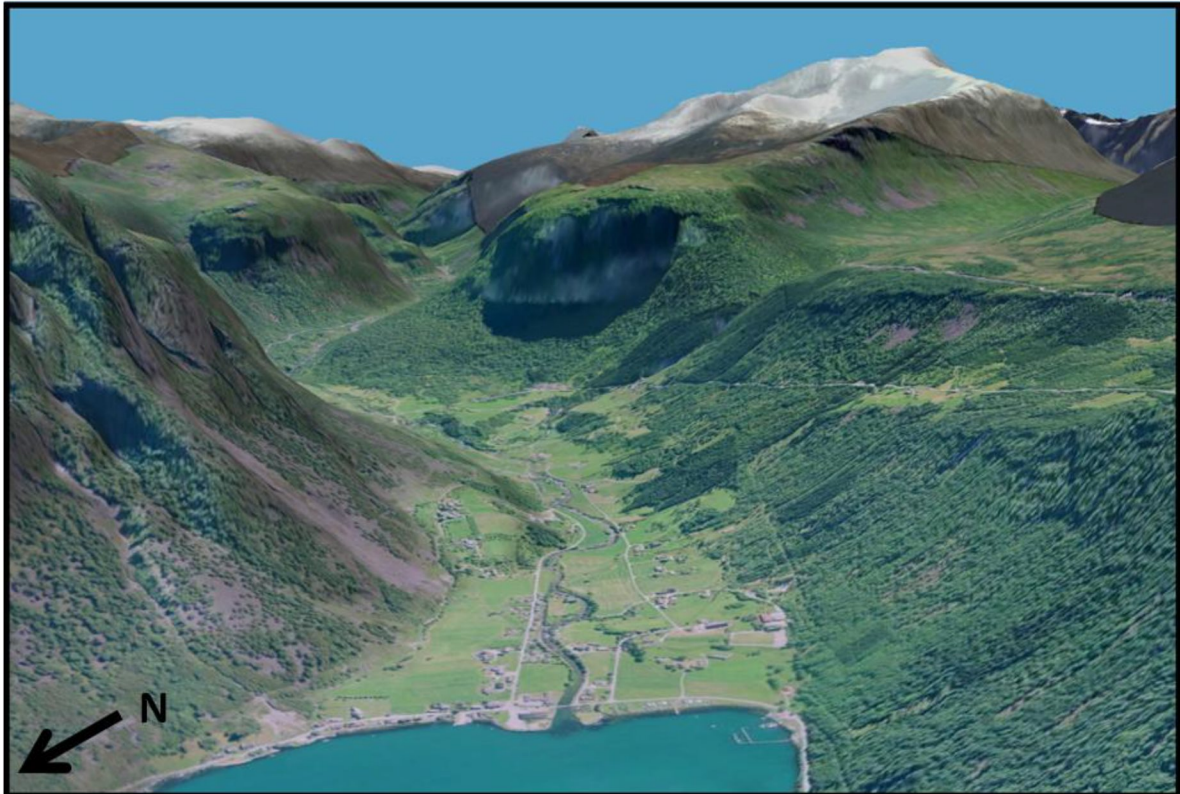
Figure 4-2: Overview of Norddal taken from North-West. Daurmålsfjellet (831m.a.s.l.) is the steep mountain face located in the middle of the picture, and the road continues into Herdalen to the left of this mountain. Picture from [www.norgei3d.no](http://www.norgei3d.no)

The settlement in *Norddal* is spread over the two-kilometer long valley with some mountain farms on the western side (see Figure 4-2). The valley terminates into the *Storfjorden* in the North and is divided by *Daurmålsfjellet* (831 m.a.s.l.) into two valleys in the South, *Herdalen* and *Dyrdalen*.

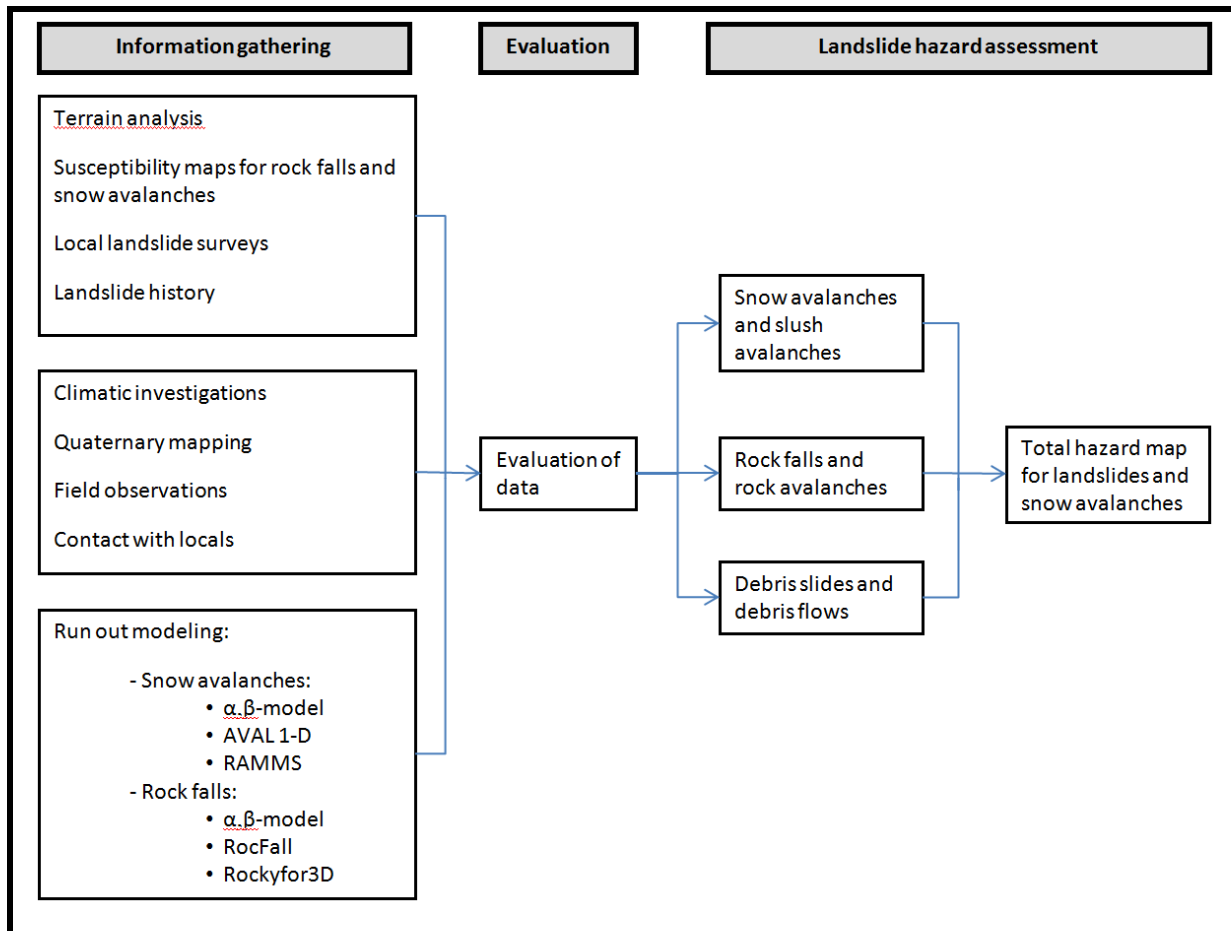
Figure 5-1: Simple schematic sketch of the methodology in this landslide hazard assessment.

The most thorough landslide hazard assessment involves combining existing, observed and modeled information (Figure 5-1). The obtainment of assessment information comprehends the gathering and evaluation of existing landslide mapping surveys, historical records, geological maps, climatic information and susceptibility maps. Initial field investigations were performed June 2<sup>nd</sup> 2012, while field work was performed during 7 days at the beginning of August 2012. Field work involved detection of local conditions which are important for the hazard zone determination, such as terrain features and vegetation. Detecting signs of present and past landslide activity were emphasized together with an information exchange with local inhabitants and the collection of data for modeling. Due to topographic conditions most of the rock face was inaccessible. Only remote investigations using binoculars were performed for the steep areas. Appendix C gives an overview of important observations determined from field work.

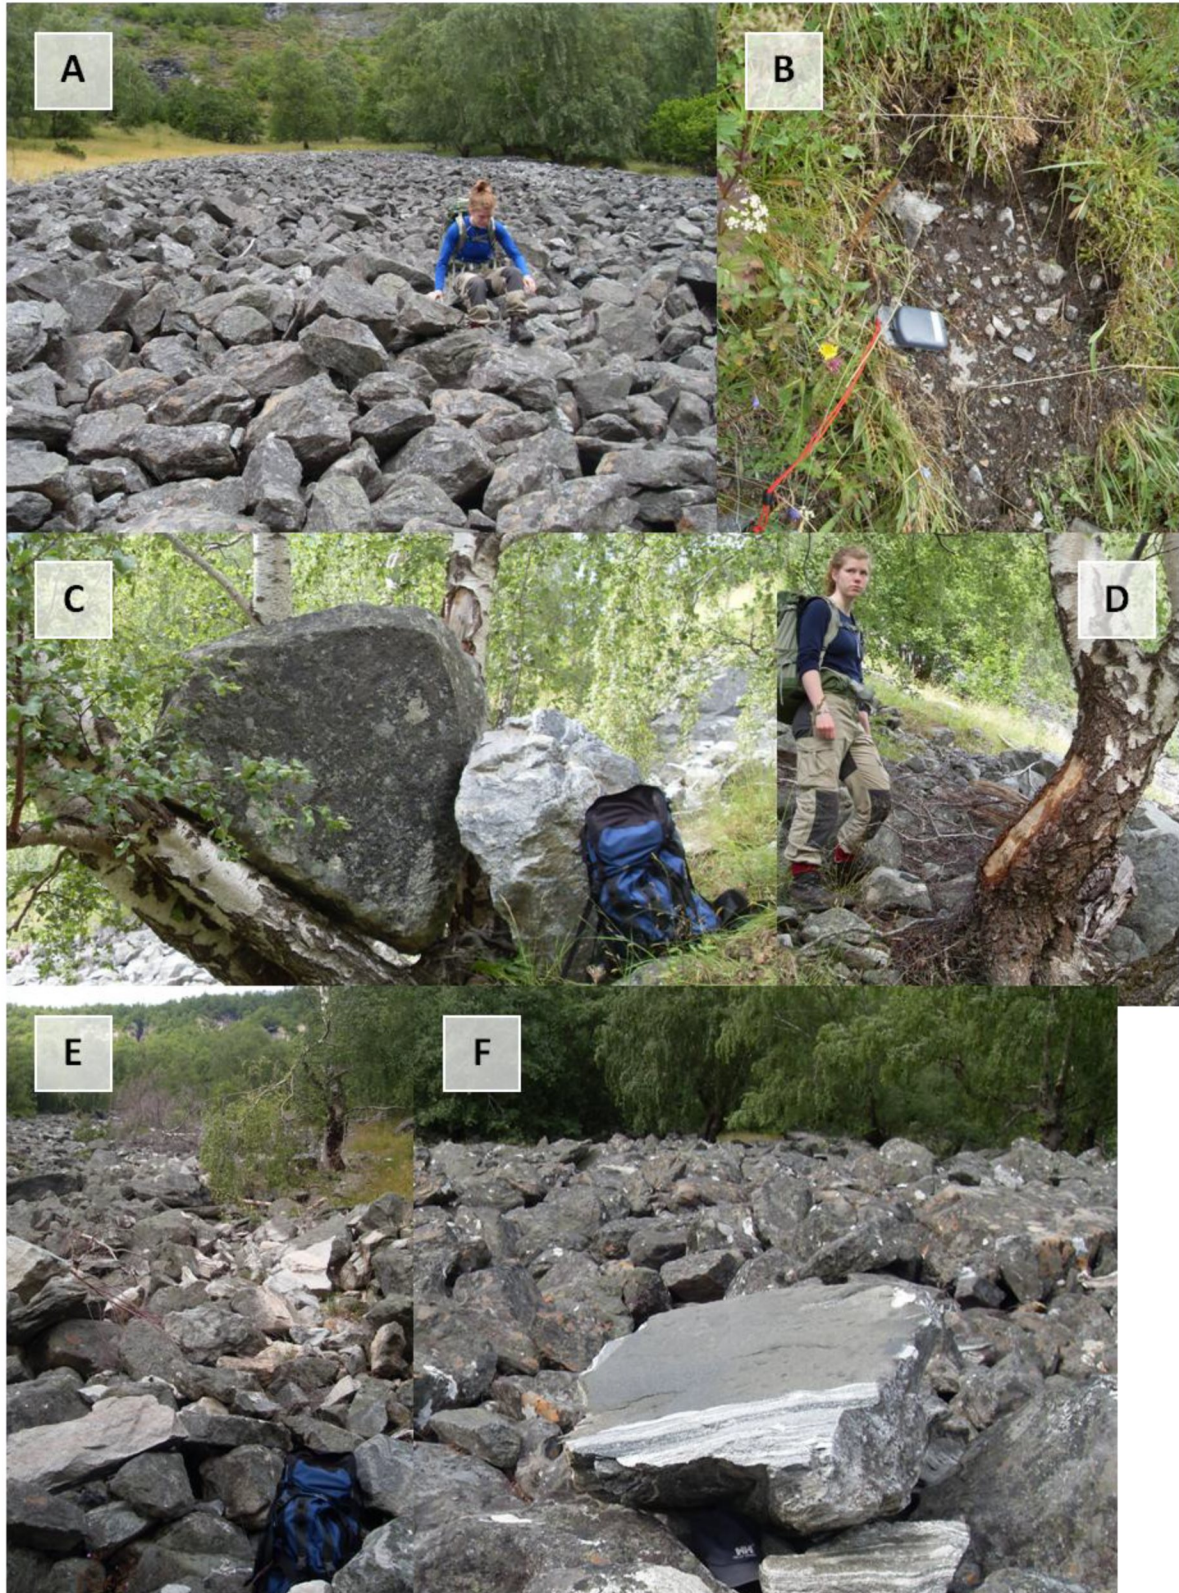
*Figure 6-3: A) Large vegetation free area on the talus, picture taken upwards. B) Trace after rock fall on the upper part of the talus. C) Rocks which have stopped toward a tree. D) Rock fall scar on a tree. E, F) Fresh rock fall deposits (Photos: N. A. Walberg).*

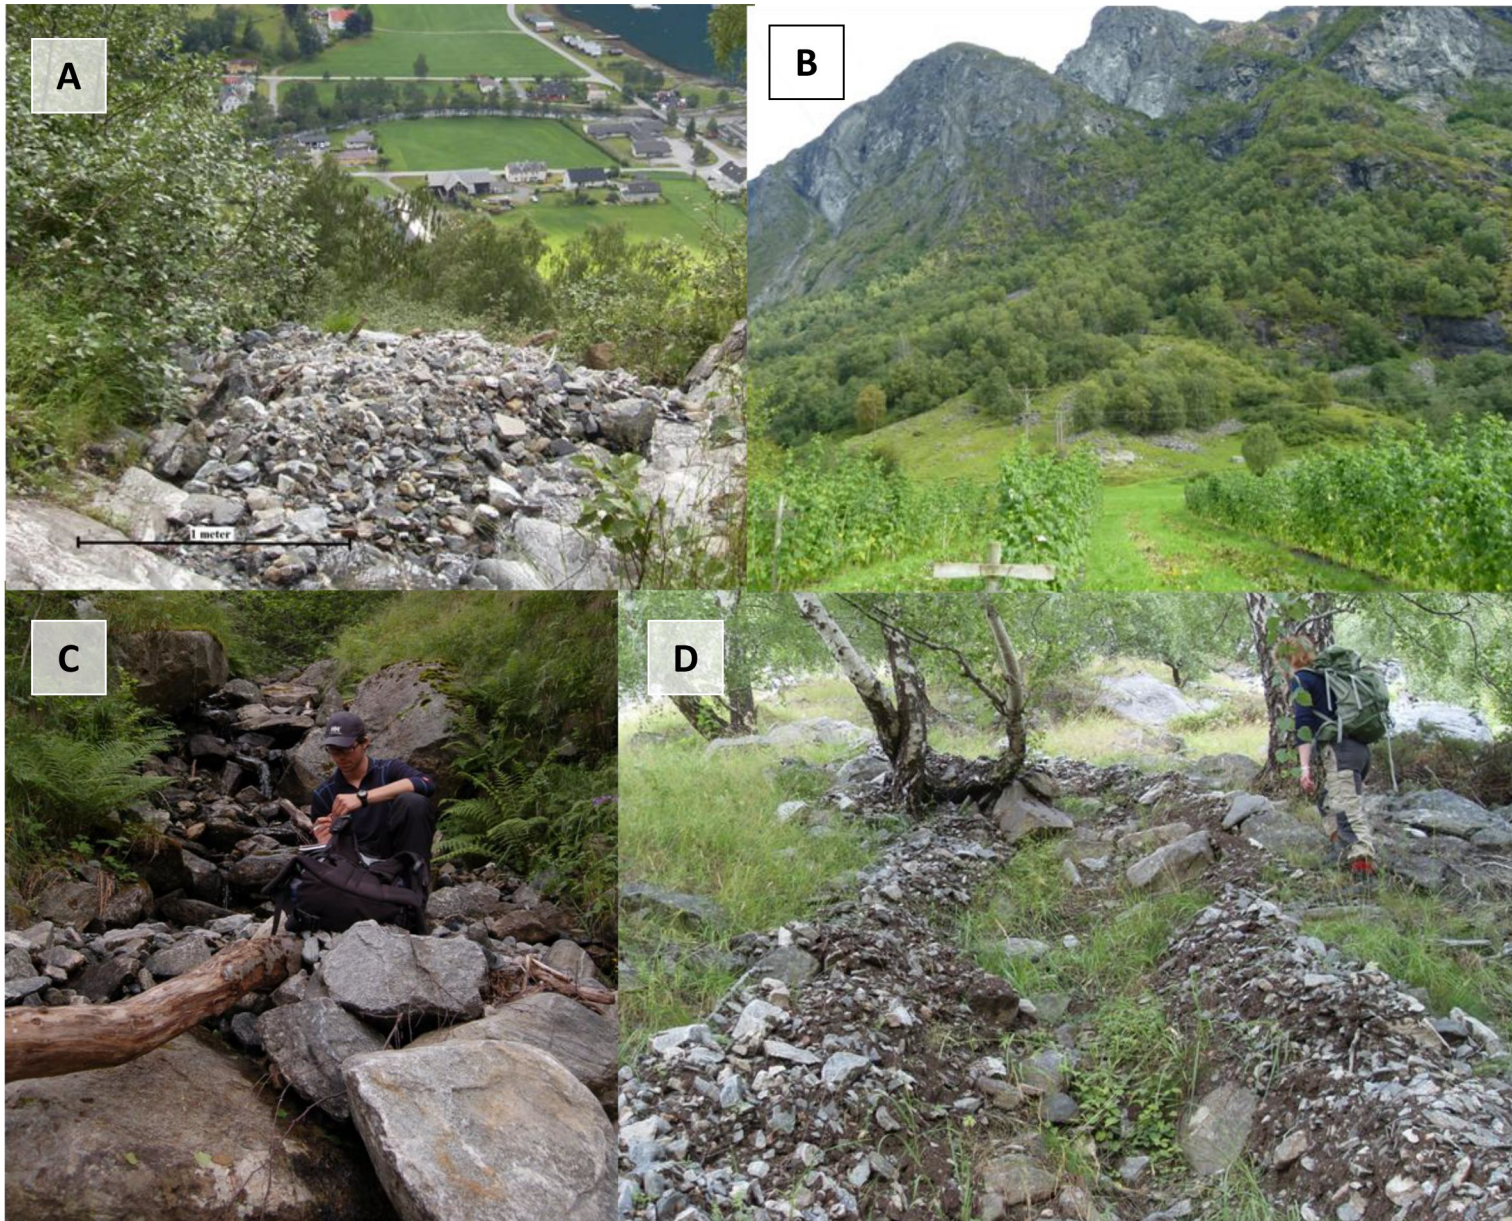
*Figure 7-3 (next page): A) Large amounts of loose material are present in the ravines in the eastern valley side. These ravines hold seasonal streams during heavy rainfall and snow melt, and probably also debris flows and snow avalanches (Photo: N.A. Walberg). B) Large fan deposits by the church. The fan is built up by several events over a long period after the last glaciations, and the upper parts show signs of recent activity (Photo: Luzia Fischer, NGU). C) Another ravine holding a small stream in the eastern valley side (Photo: M. Lund) D) Fresh deposits of levees which are thought to originate from a small slush avalanche on the talus slope (Photos: N.A. Walberg).*

The eastern valley side also shows evidence of ongoing processes related to debris flows redistributing material on the talus slope. Large amounts of available material are present in the valley side above the settlement, both in ravines (Figure 7-3A, C) and on the planar talus slope. In addition to *Kyrkjegrova*, another large fan is visible by the church indicating that debris flows in this area reach all the way to the valley floor (B). This fan shows clear evidence of how the debris flow path has changed over the years, as several geomorphologic features such as levees from different events are present. The outer part of the fan is cleared and used as agricultural land today. Also, snow- and slush avalanches are thought to redistribute material on the talus slope. Figure 7-3D shows newly deposited levees on the planar slope, which is thought to originate from a slush avalanche when the slope was snow covered, as little signs of erosion are present. Figure 7-4A shows the depositional fan by *Kyrkjegrova*, where mass is removed as a mitigation measure (Anda and Flataukan, 2002). Figure 7-4B shows massive deposits from repeating debris flow and snow avalanche events in a similar ravine 500 m north of *Kyrkjegrova*, outside the mapped area.

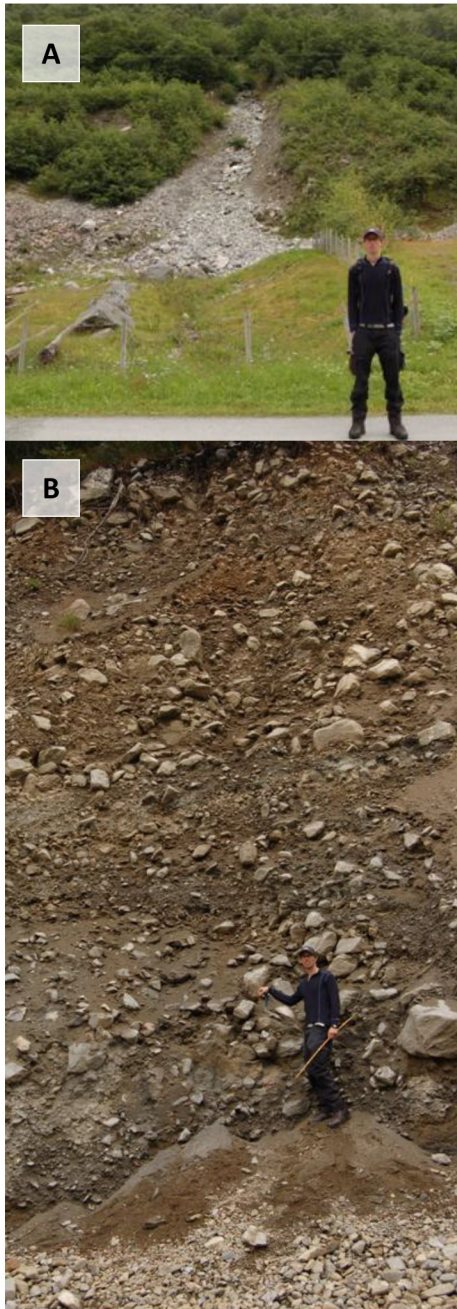
Figure 7-4: A) The lower part of Kyrkjegrova where deposits have been removed to lead new slides away from the settlement. B) Massive deposits from recurring events of debris flows, rock falls and snow avalanches 350 m north of the outermost settlement (Photos: M. Lund).

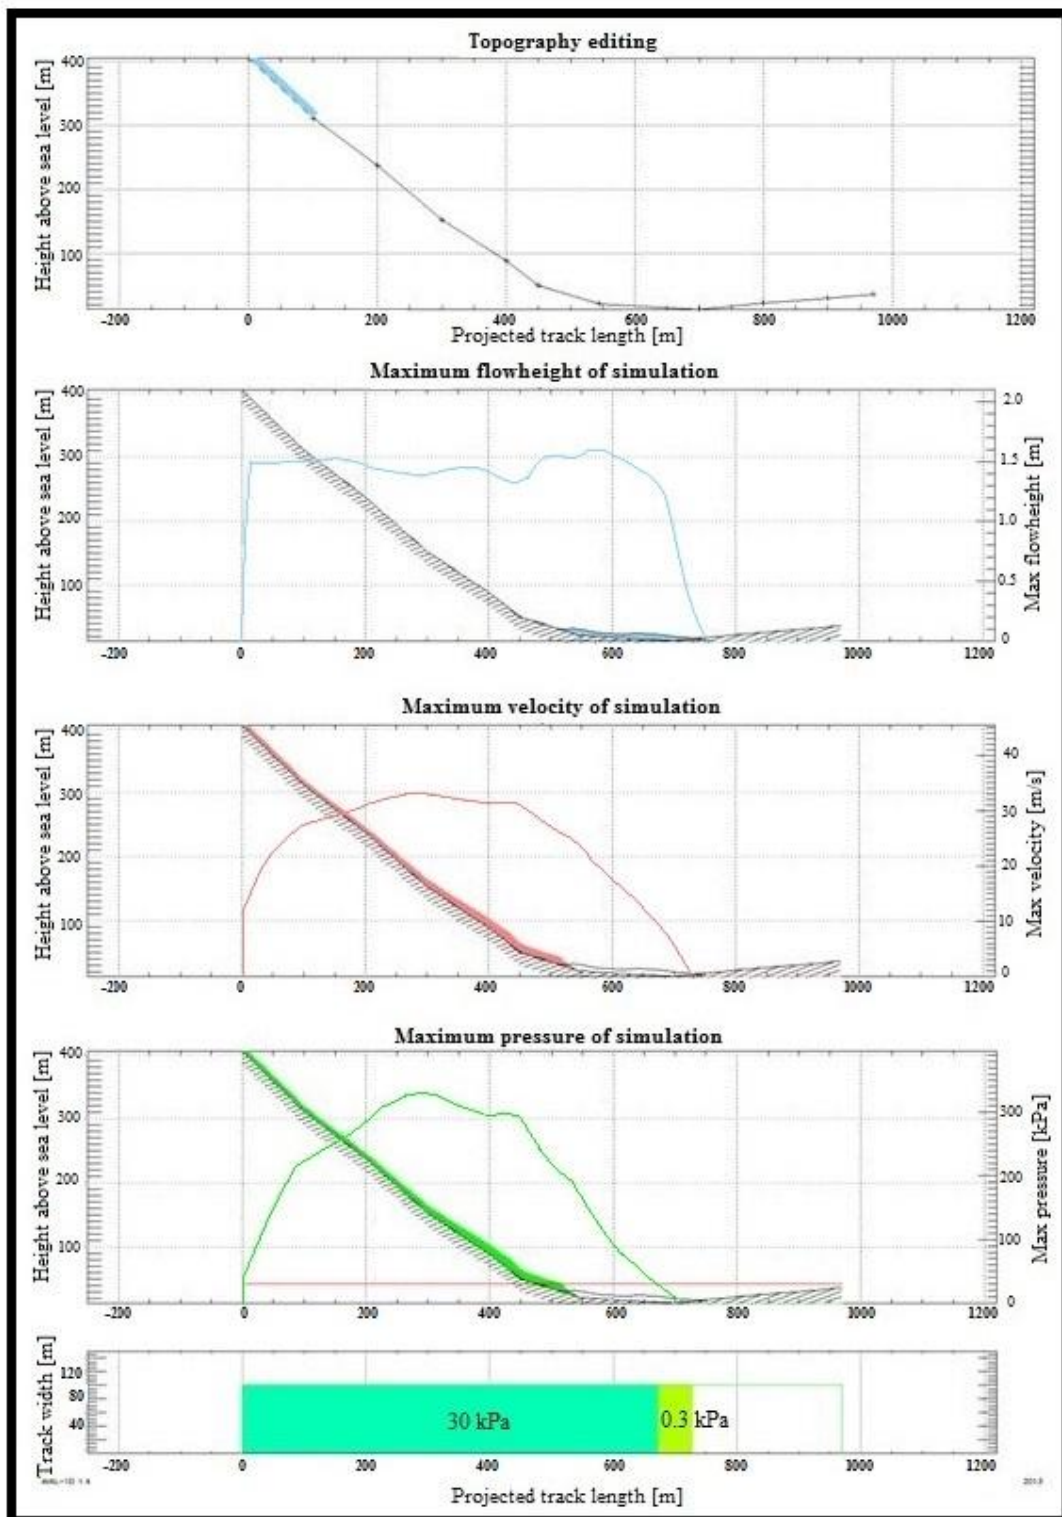
Figure 8-6: Graphical results from transect #1 determined from AVAL-1D. The uppermost graph shows the slope segments defining the slope, as well as the release area marked in blue. The graphs below show the maximum flow height, velocity, and pressure distributed down the track, while the lowermost one show endpoints of high and low pressure zones.
