## **Fish Monitoring and Live Fish Trials. Archimedes Screw Turbine, River Dart**

**Phase 1 Report: Live fish trials, smolts, leading edge assessment,  
disorientation study, outflow monitoring.**

**Client: Mann Power Consulting Ltd.**

**Project: River Dart (Ashburton)**

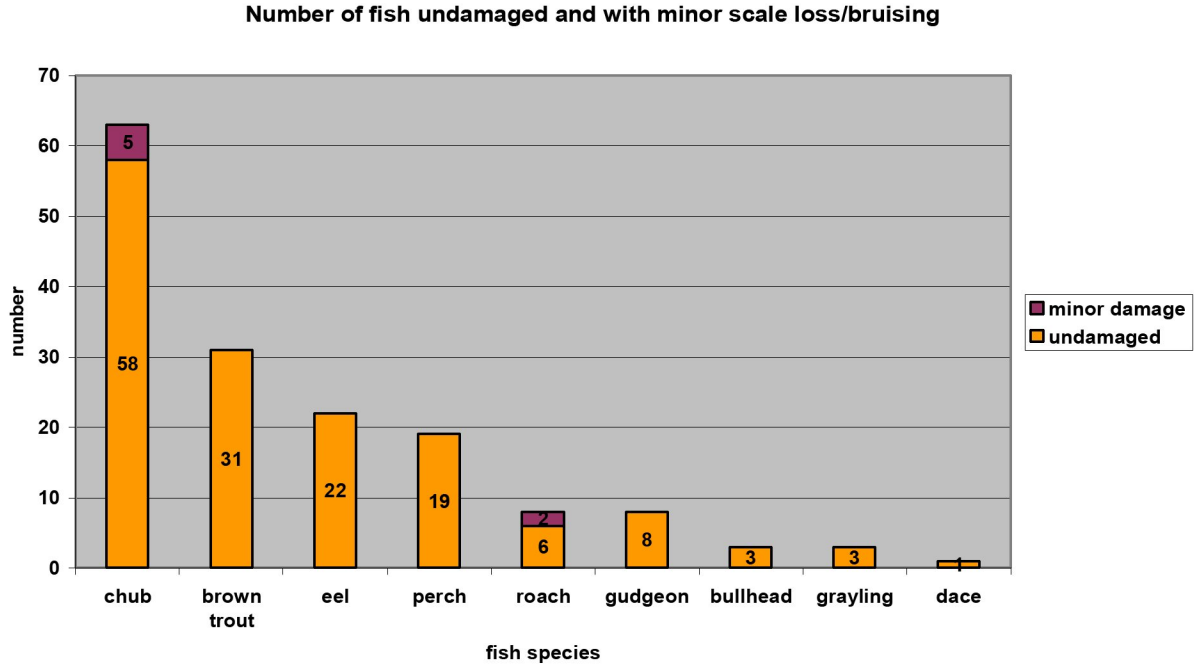
Figure 2. Results from Dr. Spah study showing species, number and number with damage.

The first assessment of fish passage through Archimedes turbines was conducted by Dr. Hartmut Spah of Bielefeld, Germany in 2001 (Spah, 2001). 158 fish of nine species were electro fished from the river, passed through the turbine and netted at the outflow. 4.4% of the fish suffered limited damage, mainly scale loss that was deemed to be minor and probably recoverable. Chub and roach were the only species to suffer any damage; eels that traditionally experience problems passing through turbines suffered no damage at all. Dr. Spah concluded that the damage was most likely due to the leading edge of the screw that had become sharpened by stones after prolonged operation.

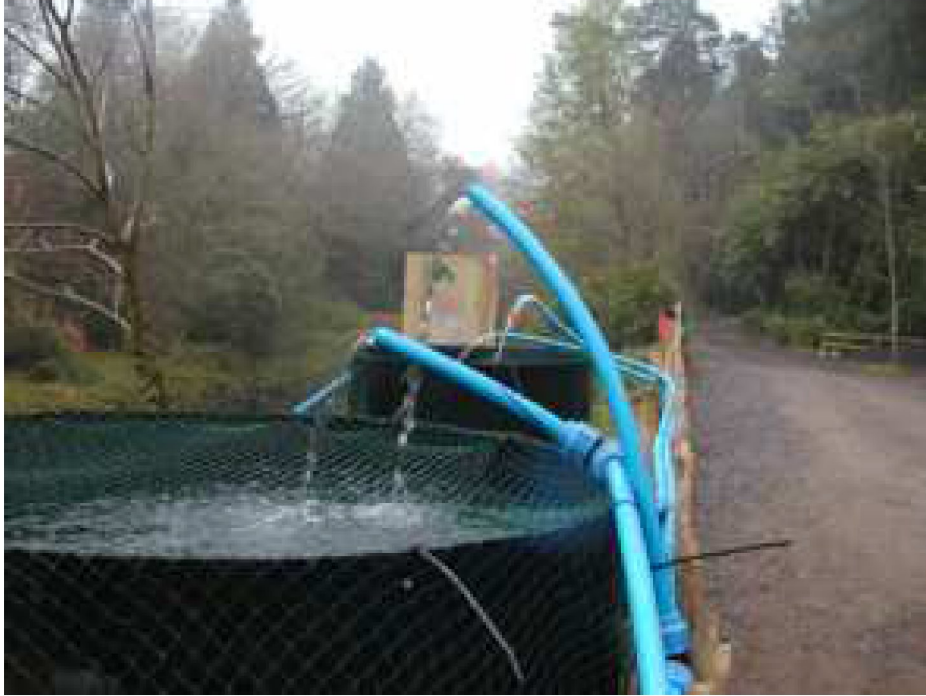
**Figure 5. 1000 litre fish holding tanks.**

Brown trout were sourced from Torr Fish Farm on Exmoor. These were reared in water with similar pH to the River Dart. Fish were kept in large 1000 litre tanks (see fig 5), with water pumped through continuously from the leat at the rate of 40 litres per minute. Two pumps were used to ensure that in the event of one failing, the fish would still receive enough water.

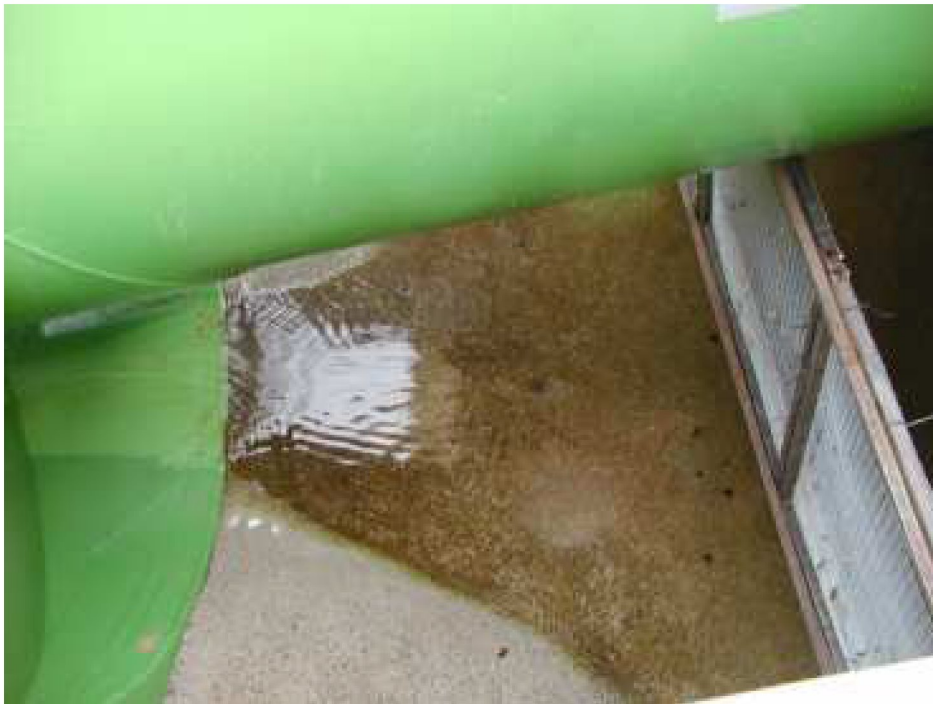
**Figure 6. Intake with fish screens**

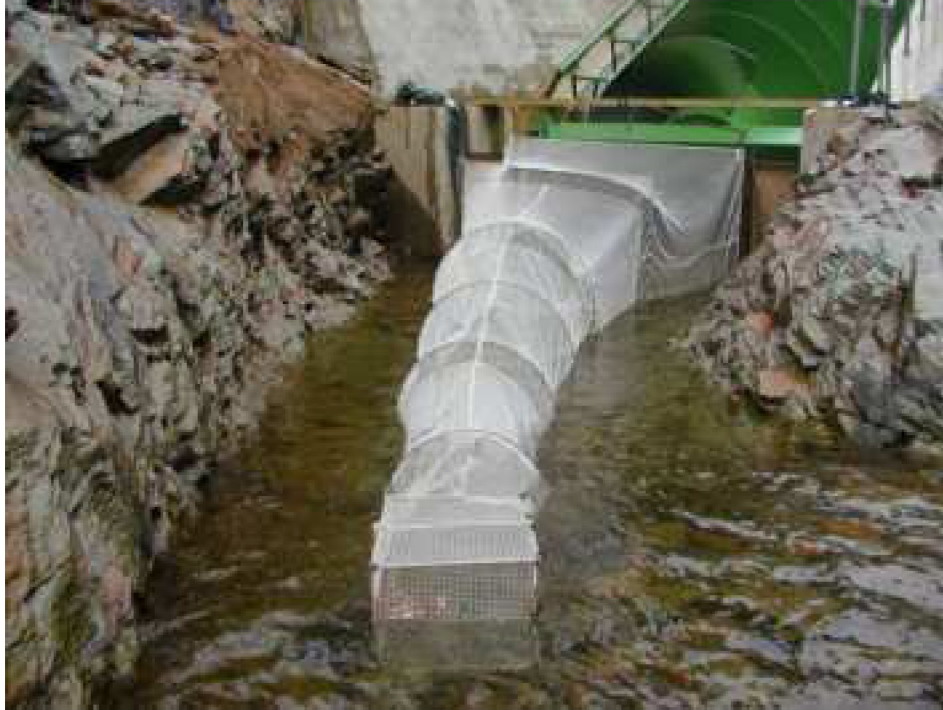
Figure 7. Fyke net at outflow.

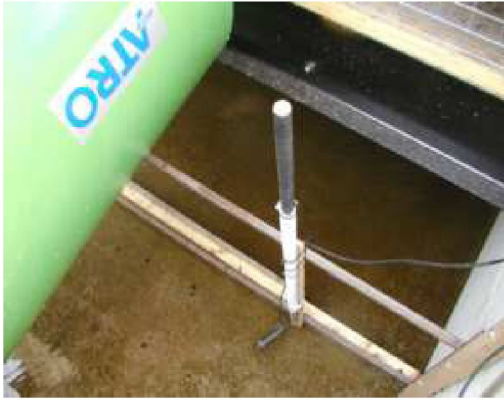
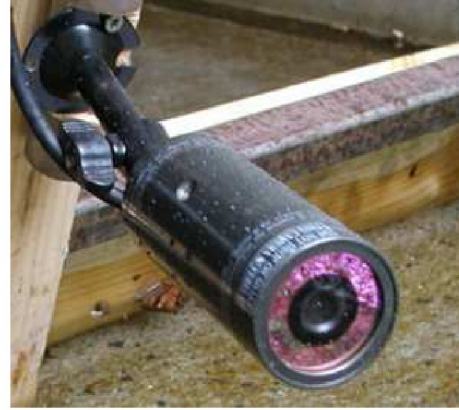
Figure 8

Fish were monitored using infra red sensitive under water cameras, as shown in figure 8 and 9 below. These record in colour during the day and switch to black and white at night. Infra red LED's built into the cameras provide a light source for night viewing, although this was boosted with additional underwater IR lights.

- Before the intake and looking directly onto the leading edge to view fish passing into the first chamber.
- Within the screw to assess if fish are exposed to high levels of turbulence that may cause disorientation.
- In the outflow box to monitor fish behaviour as they are issued from the bottom of the turbine.
- In the outflow channel and outflow box to monitor sea trout and salmon as they approach the turbine from the outflow channel.

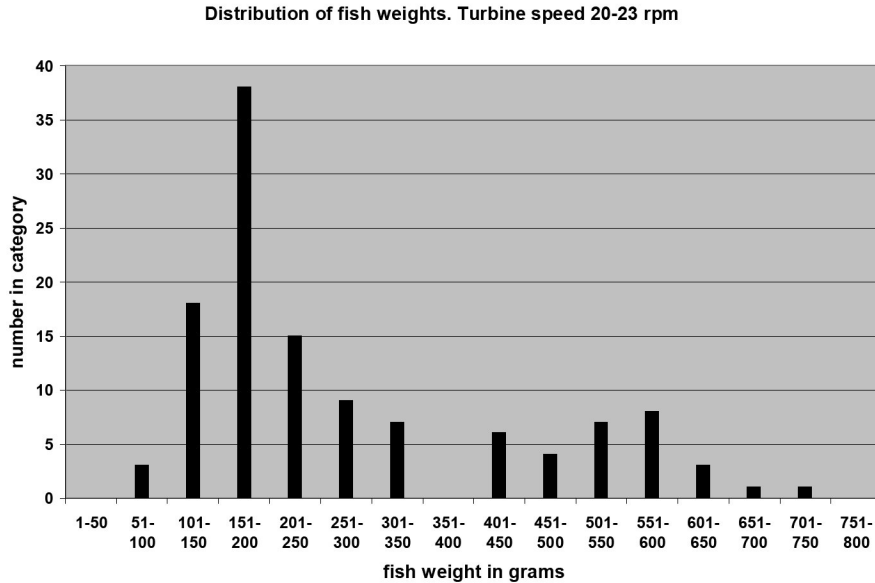
**Figure. 11**

132 fish passed through the device at this speed. The weight and length distributions are shown in figure 11 and 12. Four fish suffered limited scale loss of 5-10% (category 3). These were 17cm, 19cm, 22cm and 24 cm. The number of fish with scale loss was very low and almost the same as the net component, indicating that passage through the turbine caused no damage.

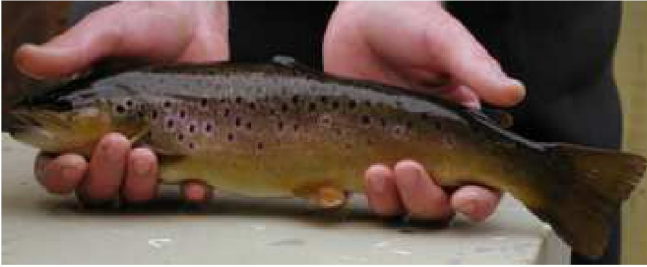
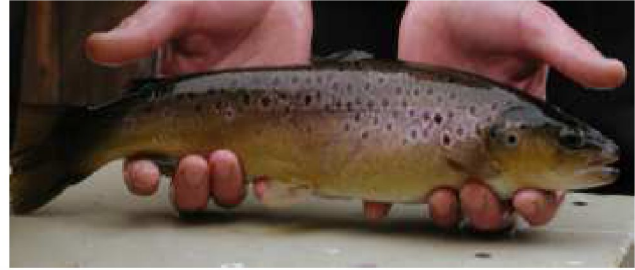
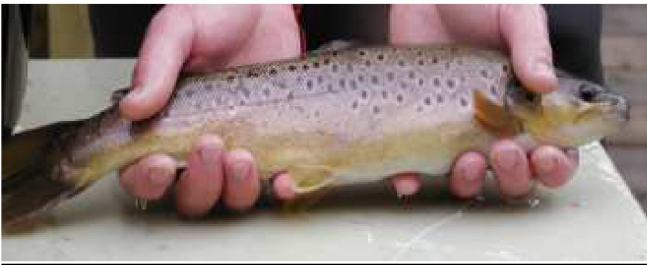
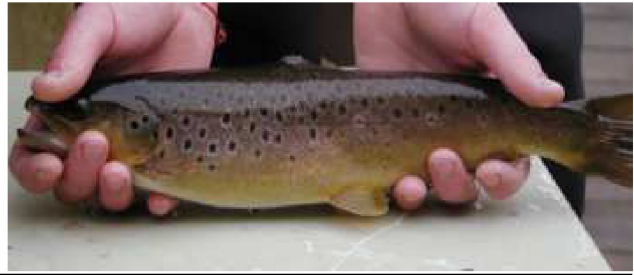
**Figure 19. The same fish before and after it has passed through the turbine.**

An example of a fish before and after passing through is shown in Figure 19 below. A fish showing minor scale loss, typical of those in category 3 is shown in Fig. 20.

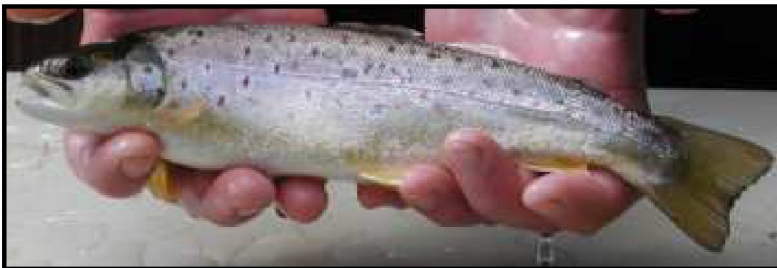
**Figure 20 A fish with category 3 damage showing limited scale loss towards the tail.**

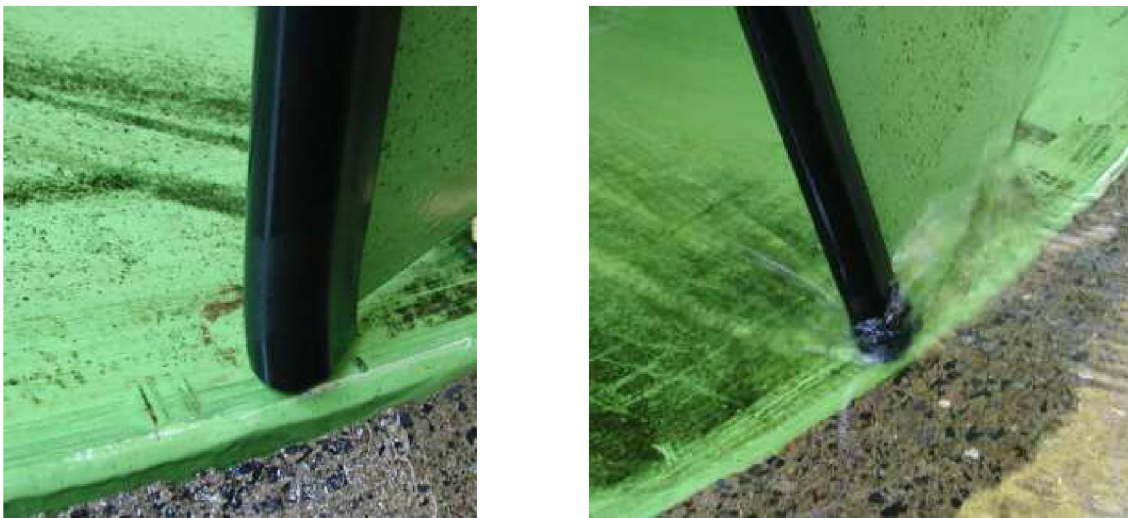
To rectify the problem, the leading edge was cut back by 50mm so it was within the trough and the bevel removed to create a straight end. In addition a rubber extrusion (see figure 28) was fitted along the entire length of the leading edge to soften any direct impact with fish, particularly large fish such as kelts with more mass and inertia. By spreading the impact over a larger area it is unlikely to cause bruising or scale loss. Dr. Spah concluded that the limited damage observed in his study was most likely caused by the leading edge becoming sharpened by stones after prolonged operation. The rubber extrusion protects the leading edge from stone damage.

The modified edge is shown in figure 28. The pinch point is removed and the extrusion (fish bumper) brushes within a few mm of the trough, preventing fish from being trapped.

Figure 28. Modified leading edge removing the pinch point.

This confirmed that the modifications to the leading edge have removed the pinch point for small fish. It is likely that eels can also pass the modified edge safely, although this will be fully evaluated in phase 2 of this report.

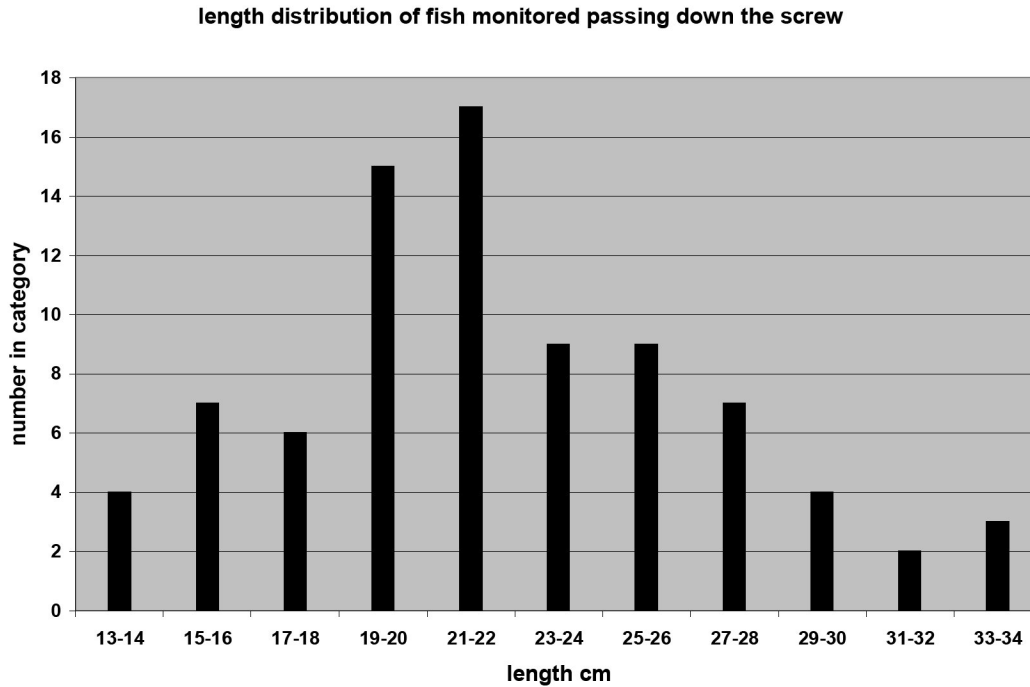
**Figure 30**

80 brown trout were filmed passing down the screw. The length distribution is shown in figure 30.
