**Archimedes Screw Turbine Fisheries Assessment.  
Phase II: Eels and Kelts.**

**Client: Mann Power Consulting Ltd.**

**March 08**

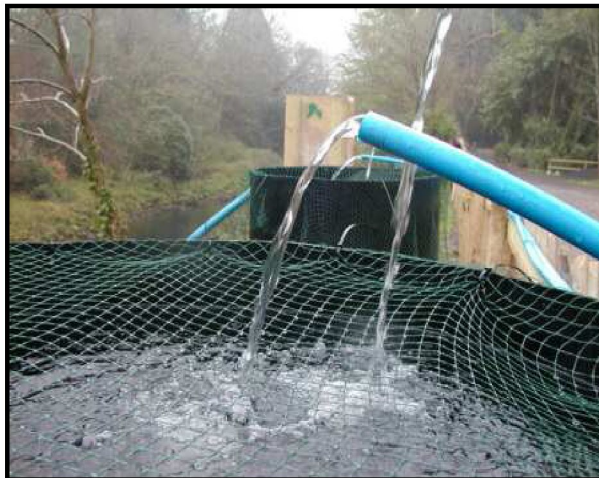
Figure 1

Eels were trapped from the wild using fyke nets and stored in 1000 liter tanks with river water pumped through at the rate of 40 litres per minute, see figure 1.

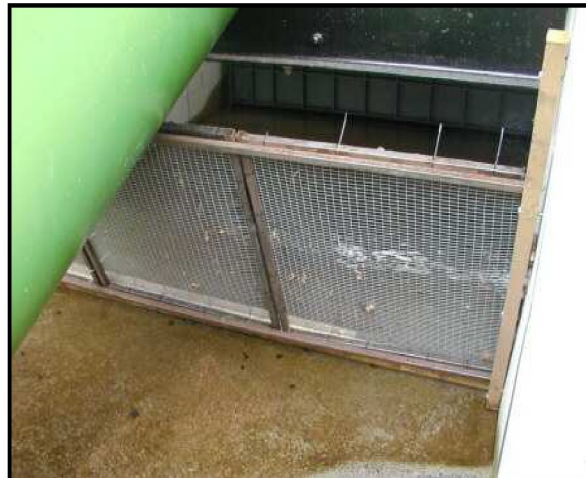
Figure 2

They were introduced approximately 1m behind the leading edge via a 110mm diameter fish pipe referred to in Phase 1 (See Phase 1 DVD). This ensured eels entered the turbine near the base, maximising exposure to the leading edge and hence the risk of injury. A screen of 10mm x 10mm galvanized steel mesh was installed in the forebay tank to prevent them escaping into the leat, see figure 2. A second screen at the outflow trapped the eels after they had passed through.

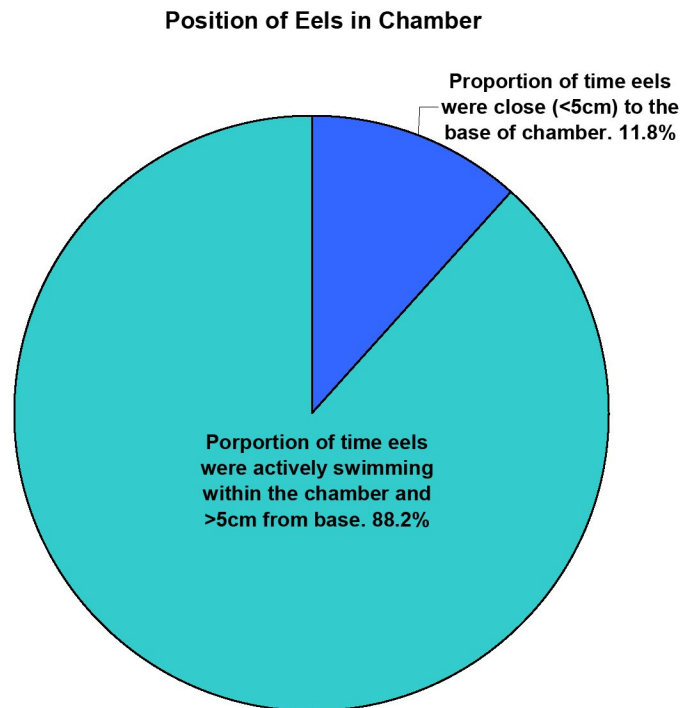
Inside the chamber, eels behaved in an unexpected way. Rather than remaining close to the bottom with heads facing upstream and tails down stream, most held their tails well up in the water column and heads towards the bottom of the trough, or actively moved around the chamber. It is likely this was due to the circulation of water from the trough floor to the surface, with the eels holding station against the flow. This is interesting, as it explains why very few (0.64%) suffered pinched tails. By actively swimming around the chamber, the tails are held away from the gap between the helix and the trough.

The proportion of time spent within a few cm of the trough compared to swimming actively in the water column is shown in figure 10.

**Figure 10. Position of eels as they pass through turbine**

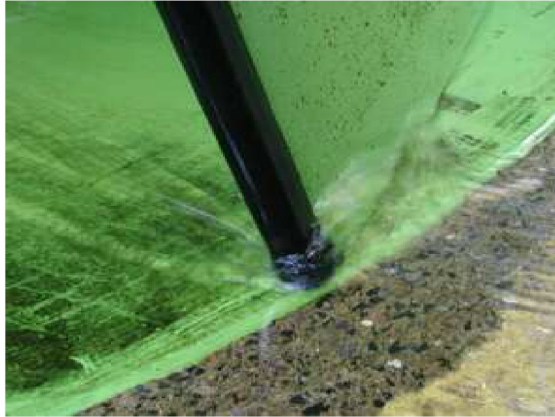
The bumpers fitted to the leading edge were assessed after 8 months of continuous operation. They were in perfect condition (see appendix) and could be expected to last for 5-10 years.

**Rubber extrusion (fish bumper) after fitting**
