## **HOWSHAM FISH MONITORING**

**Assessment of fish passage through the  
Archimedes Turbine and associated by-wash**

**Client: Mann Power Consulting**

**August 2009**

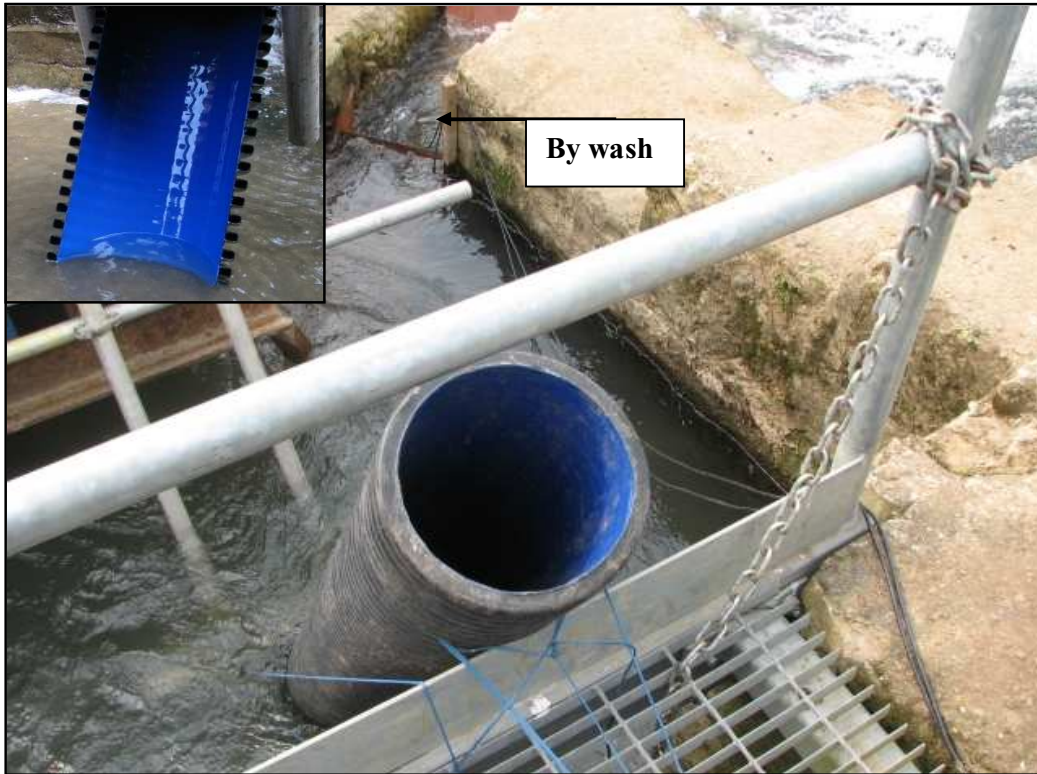
**Figure 2:** photo showing the pipe used to introduce fish to the intake area above the turbine and by-wash, and the escape window at the end of the pipe (inset).

The by-wash (see figure 2) was created in the side of the turbine intake channel, 2 m before the leading edge. A notch 50 cm wide x 50 cm (below water level) was cut into the stone work with a bell mouth entrance leading up from the floor of the forebay tank. The by-wash was open to the atmosphere with no dark passages that might deter fish from entering. Total flow in the by-wash was calculated using the equation for a rectangular thin-plate weir with side contractions, given in the Environment Agency Fish Pass Manual. (See appendix for calculation). The by-wash flow of 312l/s equated to 10-15% of the maximum turbine flow, considered to be a reasonable proportion of total flow for a by-wash channel.

Fish were subsequently introduced to the intake area immediately upstream of the turbine and by-wash, through a 200mm diameter pipe with an escape window cut in the end (see insert, figure 2). Underwater video cameras were installed in the intake area and by-wash to monitor fish behaviour.

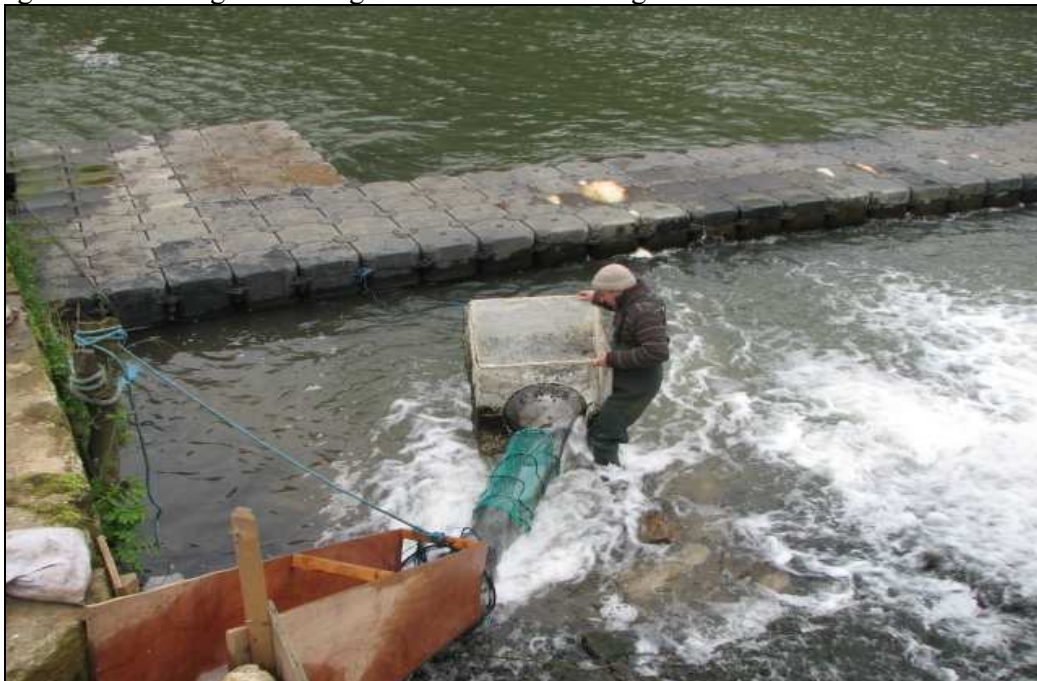
A chute was created to transfer fish from the exit of the by wash into a netted holding box with a volume of 1m<sup>3</sup>, sited in an area of low flow to ensure fish were not forced against the netting and damaged. This is shown in figure 3.

**Figure 3:** photograph illustrating the chute and holding box.

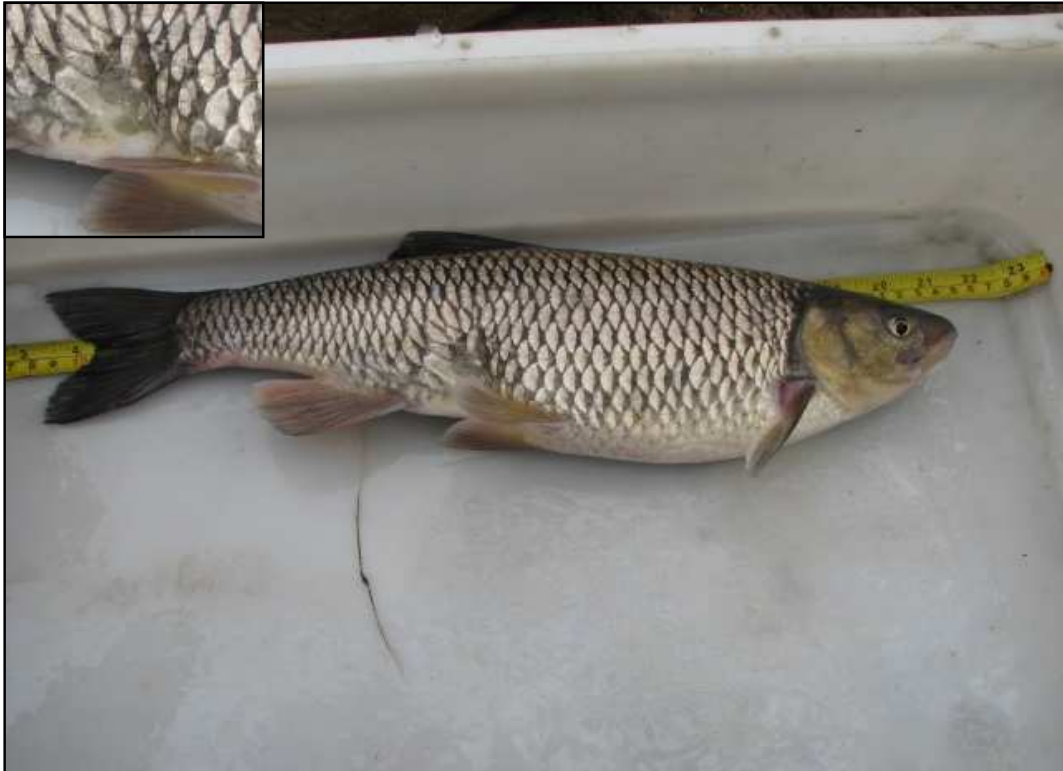
Figure 6: chub displaying scars from previous damage, possibly inflicted by a pike or piscivorous bird

No damage was caused to any fish as a result of passage through the screw. However, some fish had pre-existing damage (see Appendix), displaying old wounds from an attack by piscivorous fish, probably pike as there were a lot of pike in this section of the Derwent.

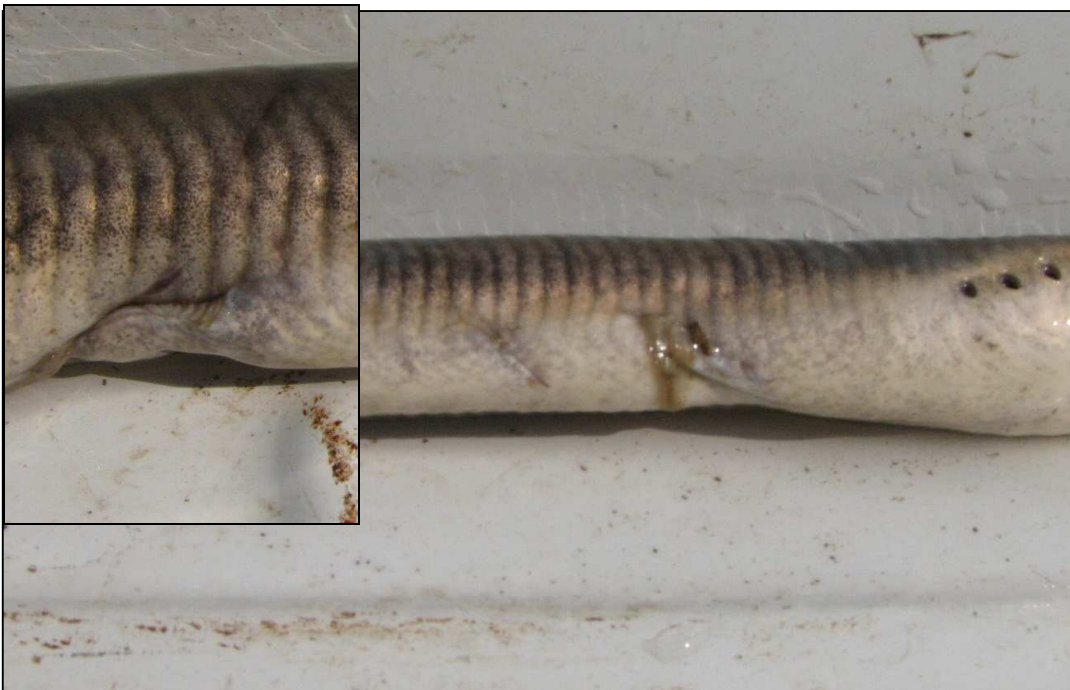
Figure 7: lamprey displaying indications of damage from a pike attack

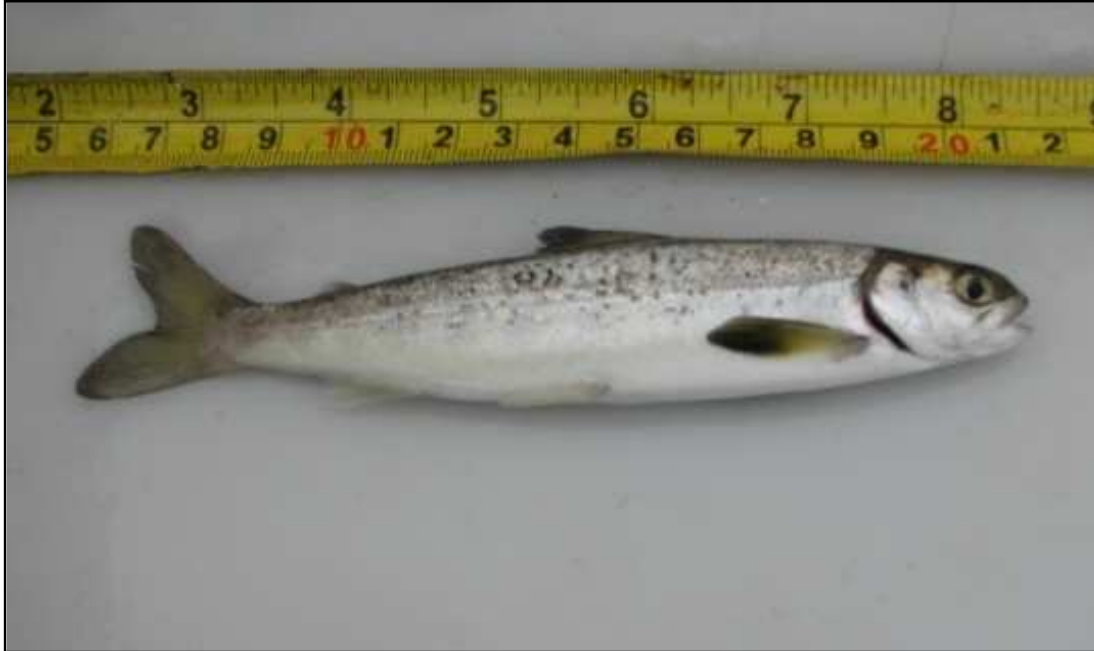
**Figure 8: salmon smolt caught passing naturally downstream through the turbine**

A salmon smolt was also caught after passing naturally through the turbine (see Appendix). This suggests that adult salmon are occasionally ascending the weir and spawning upstream, or stocking of fry/parr has been conducted in recent years.

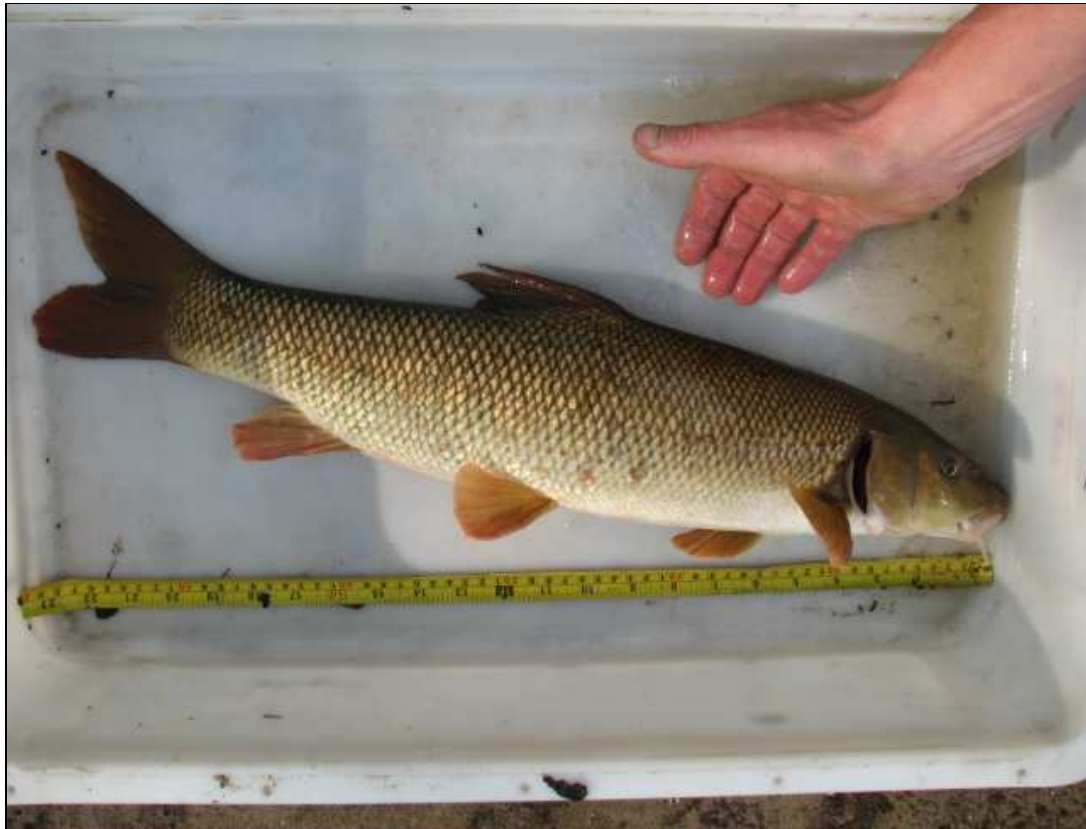
**Figure 9: 60cm barbel after passing through turbine**

A wide range of species were used in the study. The number of individuals of each species introduced into the intake area at the head of the turbine/by-wash, or passing through naturally and their maximum lengths are given in table 1. Pictures of some of the larger pike and barbel after passing through the screw are shown in the appendix.

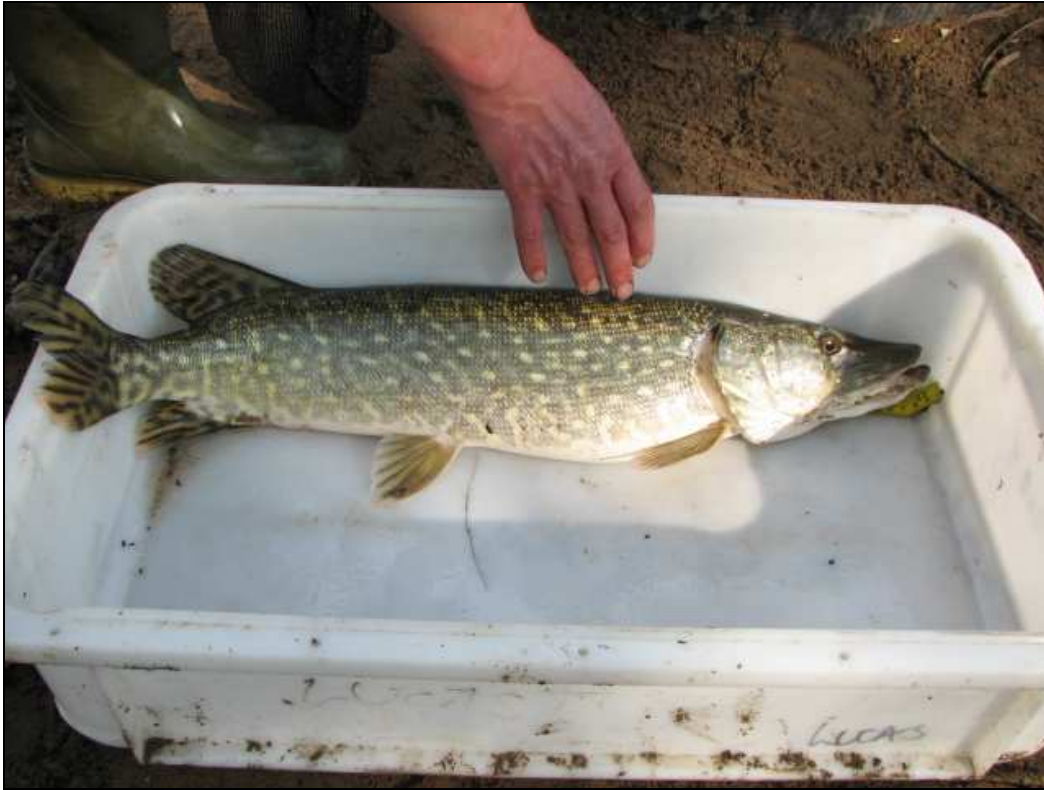
**Figure 11: 73cm pike after passing through turbine**
